RESEARCH MEMORANDUM

STABILITY AND CONTROL DATA OBTAINED FROM

FIRST FLIGHT OF X-4 AIRPLANE

By Hubert M. Drake

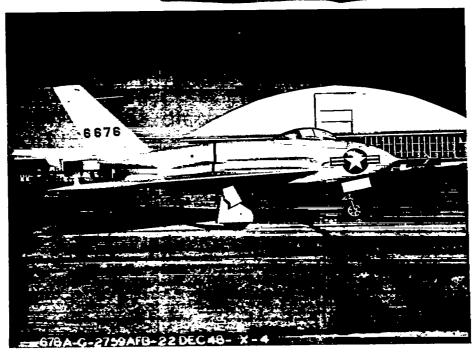
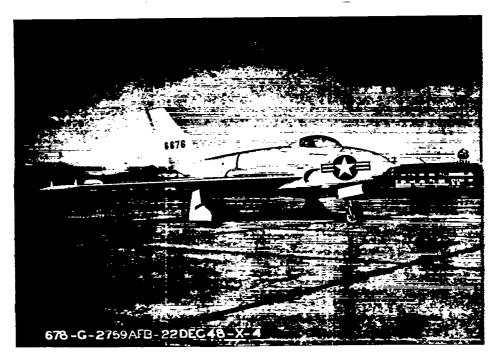
Figure Photography Photography

The Northrop X-4 airplane is a semi-tailless research airplane having a vertical tail but no horizontal tail surfaces. It is powered by two Westinghouse J30-WE-7-9 engines and is designed for flight research in the high subsonic speed range. Photographs of the airplane are presented as figure 1 and a three-view drawing as figure 2. Table I lists the physical characteristics of the airplane.
